FINAL NON TIME CRITICAL REMOVAL ACTION AFTER ACTION REPORT SOLID WASTE
MANAGEMENT UNIT 4 (SWMU 4) ATLANTIC FLEET WEAPONS TRAINING AREA FORMER
NAVAL AMMUNITION SUPPORT DETACHMENT VIEQUES ISLAND PUERTO RICO

**Solid Waste Management Unit 4
Non-Time-Critical Removal Action
After Action Report**

**Atlantic Fleet Weapons Training Area—Vieques
Former Naval Ammunition Support Detachment
Vieques, Puerto Rico**

November 2016

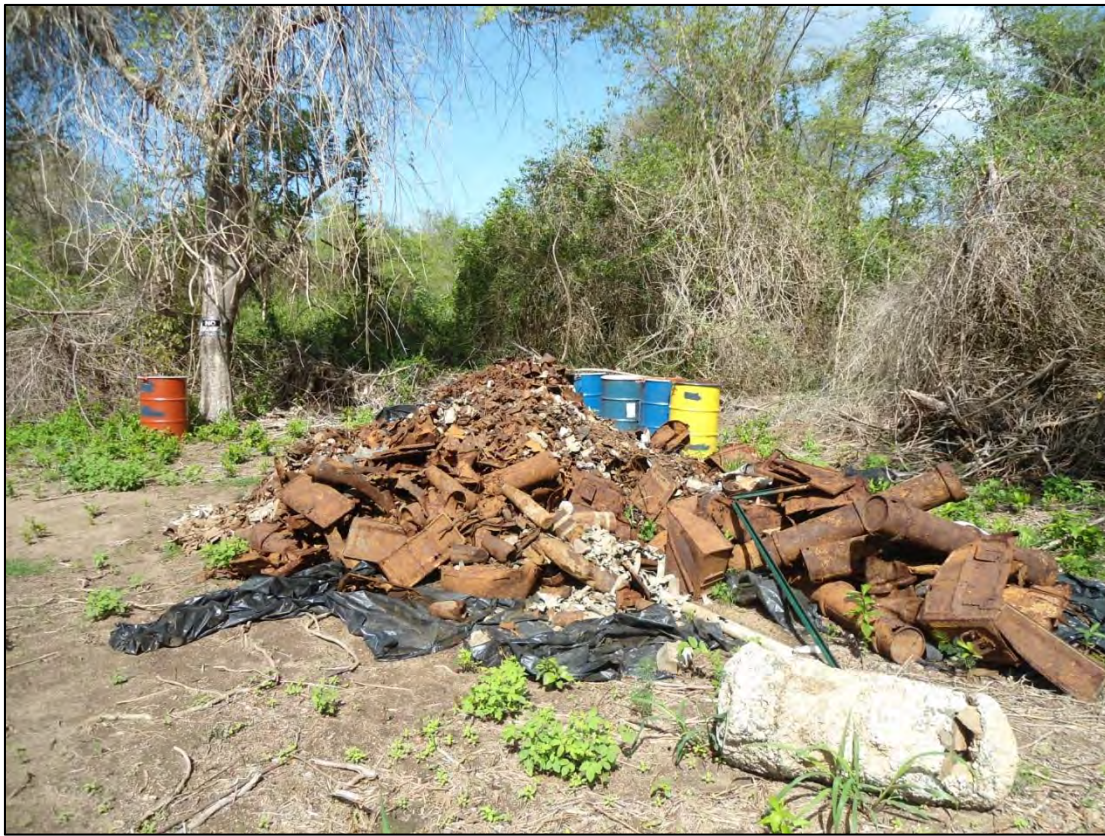
Photo 29 – MDAS, MD, and/or RRD recovered during the NTCRA at SWMU 4

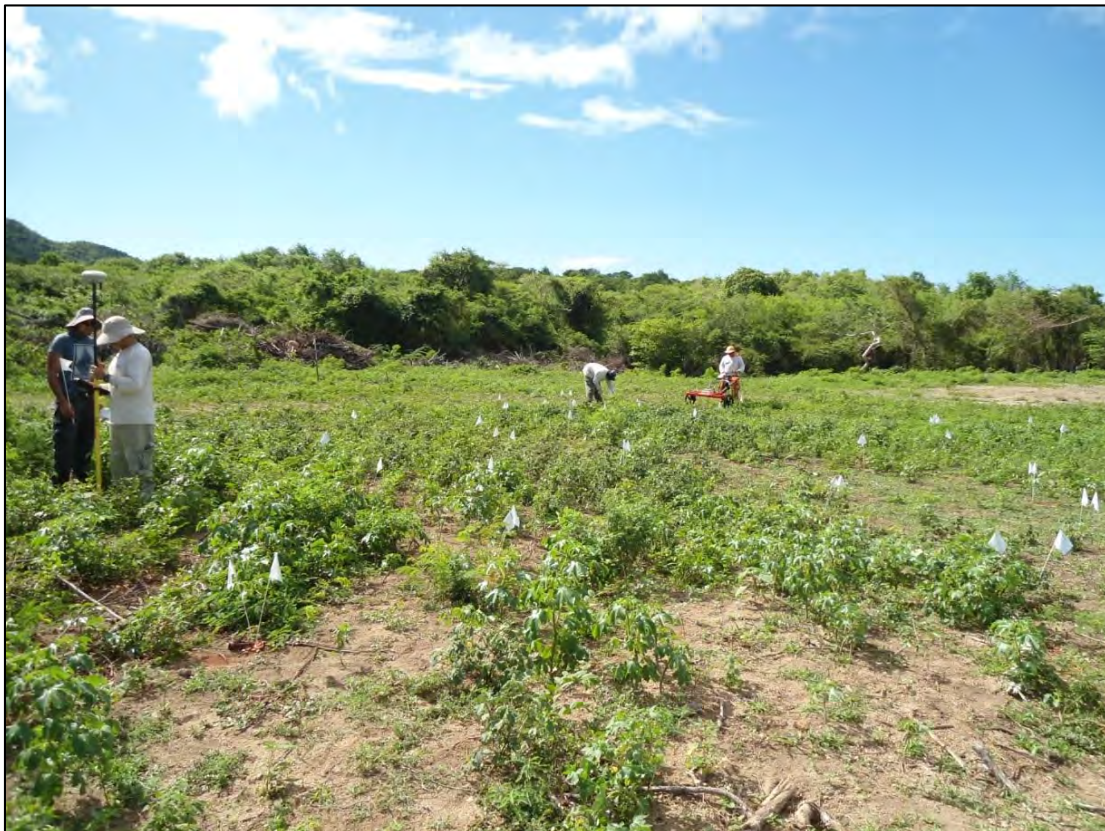
Photo 30 – Team reacquiring anomalies at the planned picnic area at SWMU 4

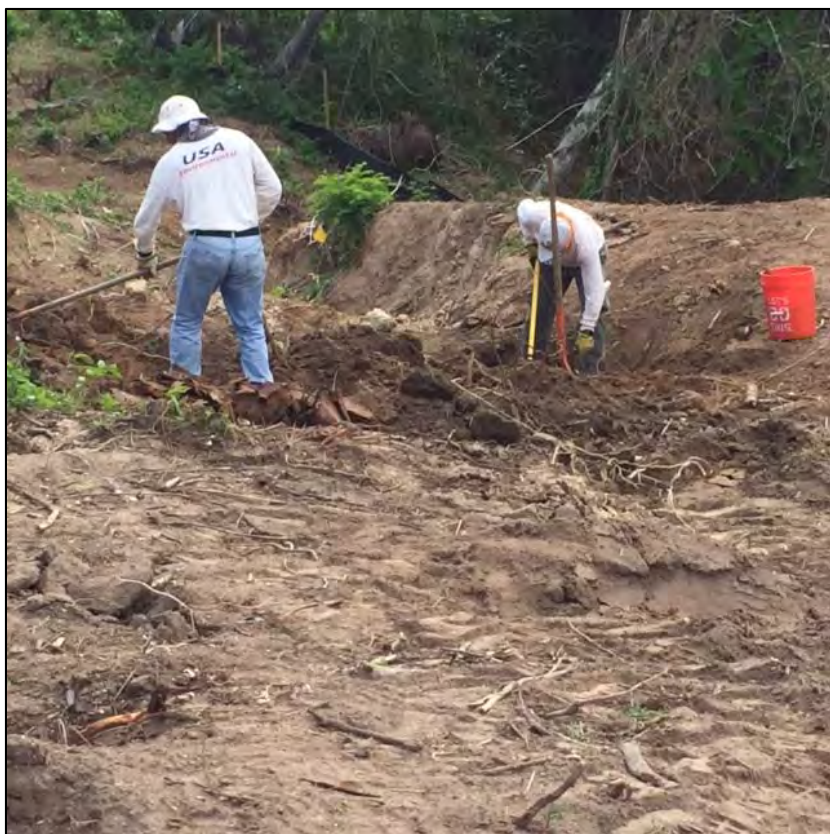
Photo 31 – Mag-and-dig at the planned picnic area at SWMU 4

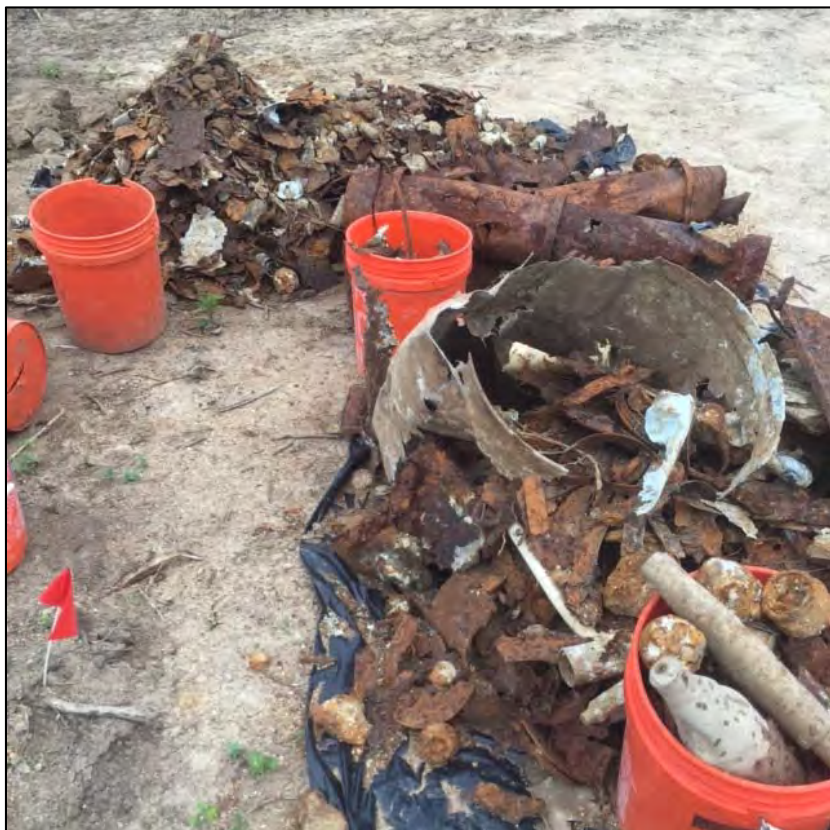
Photo 32 – MDAS, MD, and/or RRD recovered at SWMU 4

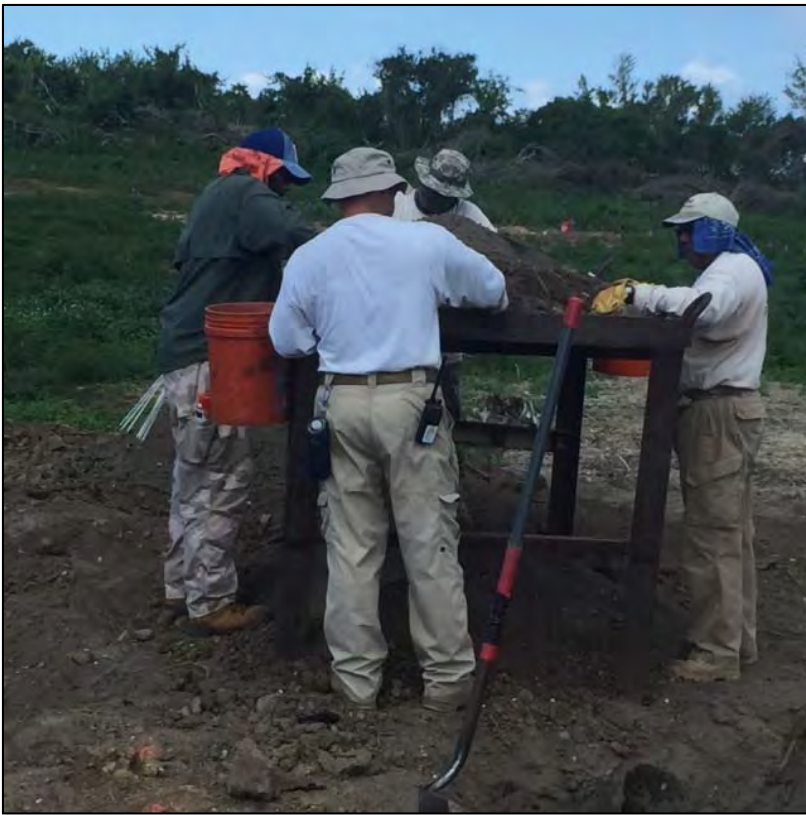
Photo 33 – Screening to remove small metallic items from excavated soil at SWMU 4

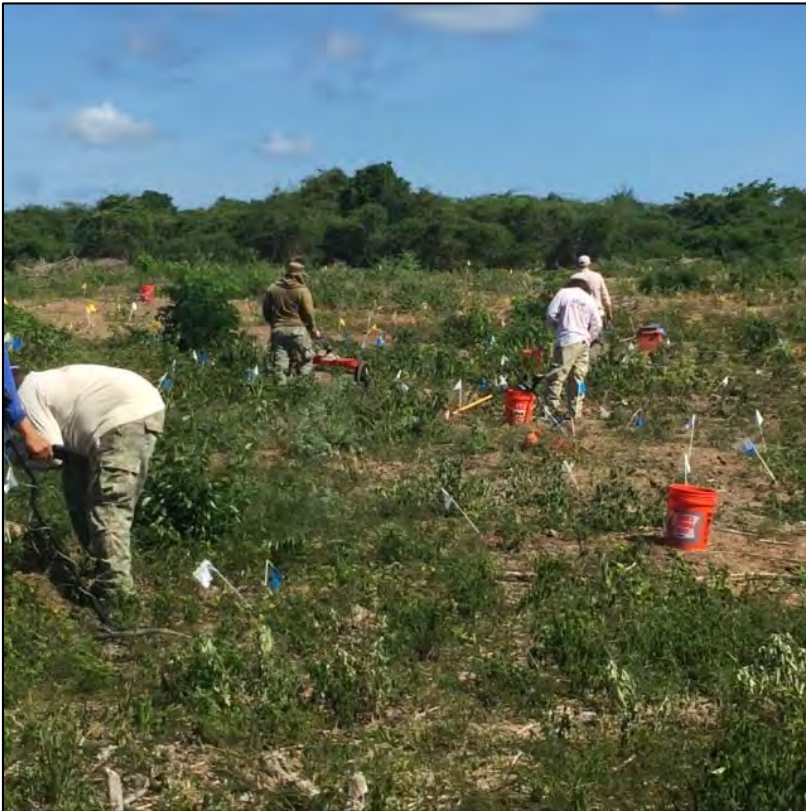
Photo 34 – Excavating DGM anomalies; flags mark the locations where anomalies have been identified through DGM and have been reacquired by the removal team

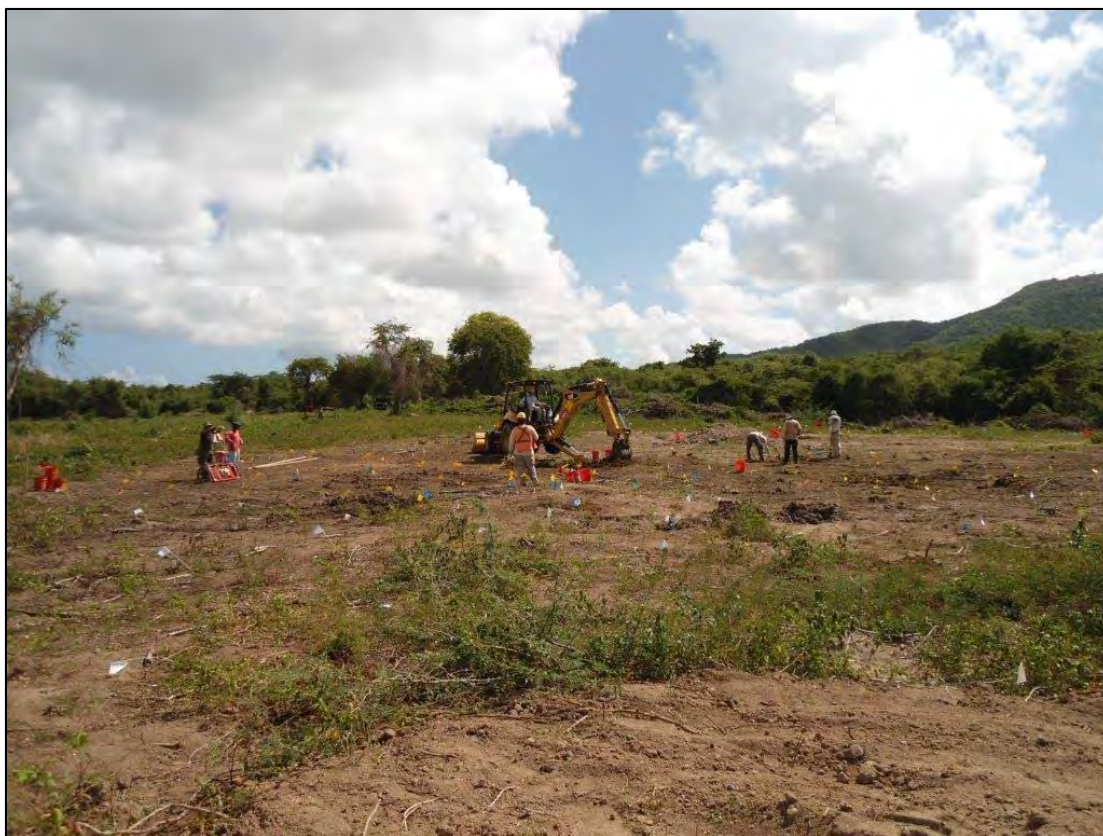
Photo 35 – Backhoe use in the planned picnic area at SWMU 4

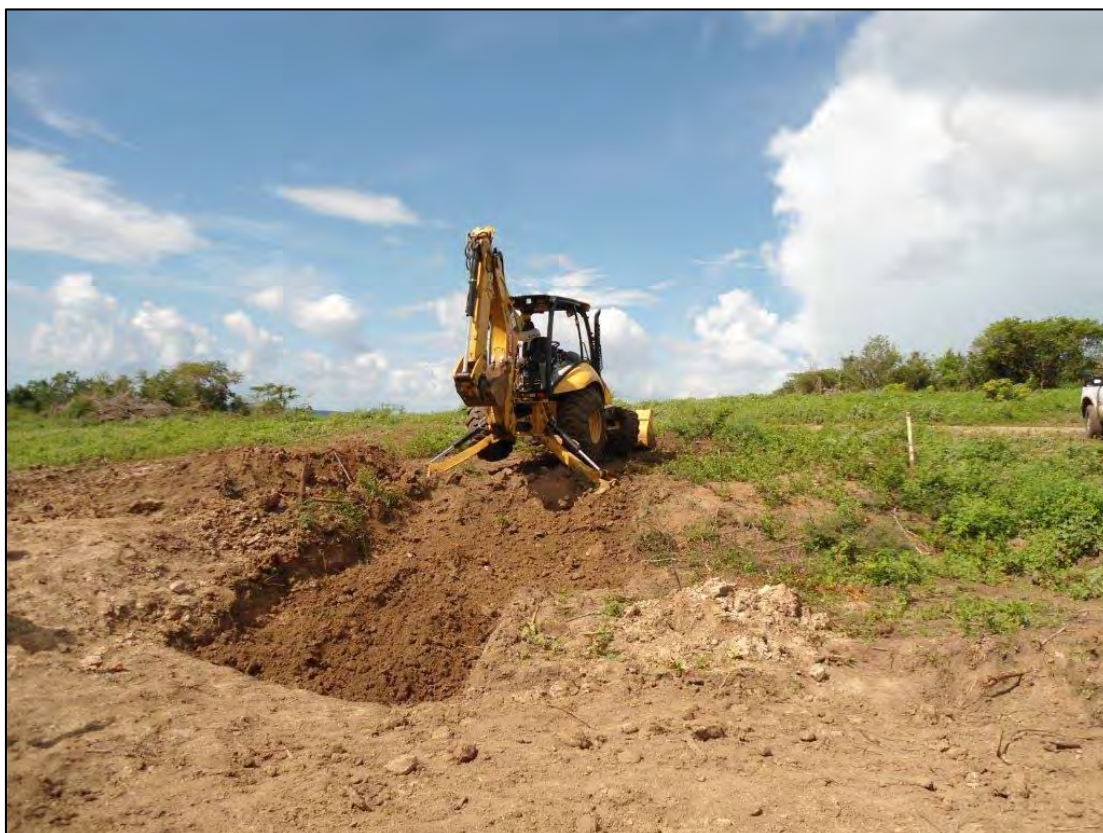
Photo 36 – OB/OD location being excavated during mag-and-dig at SWMU 4

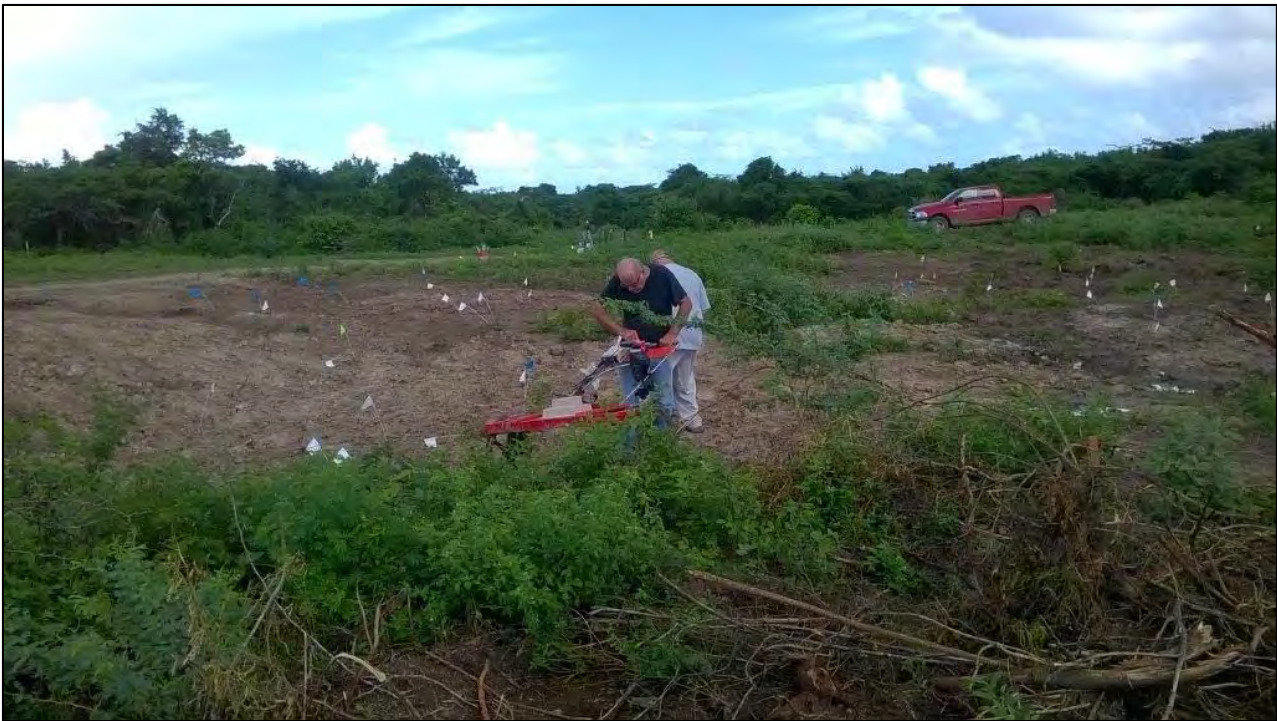
Photo 37 – Quality assurance checks of the excavated anomalies at SWMU 4
